## HRS DOCUMENTATION RECORD--REVIEW COVER SHEET

Name of Site: Keystone Corridor Ground Water Contamination

## HRS DOCUMENTATION RECORD

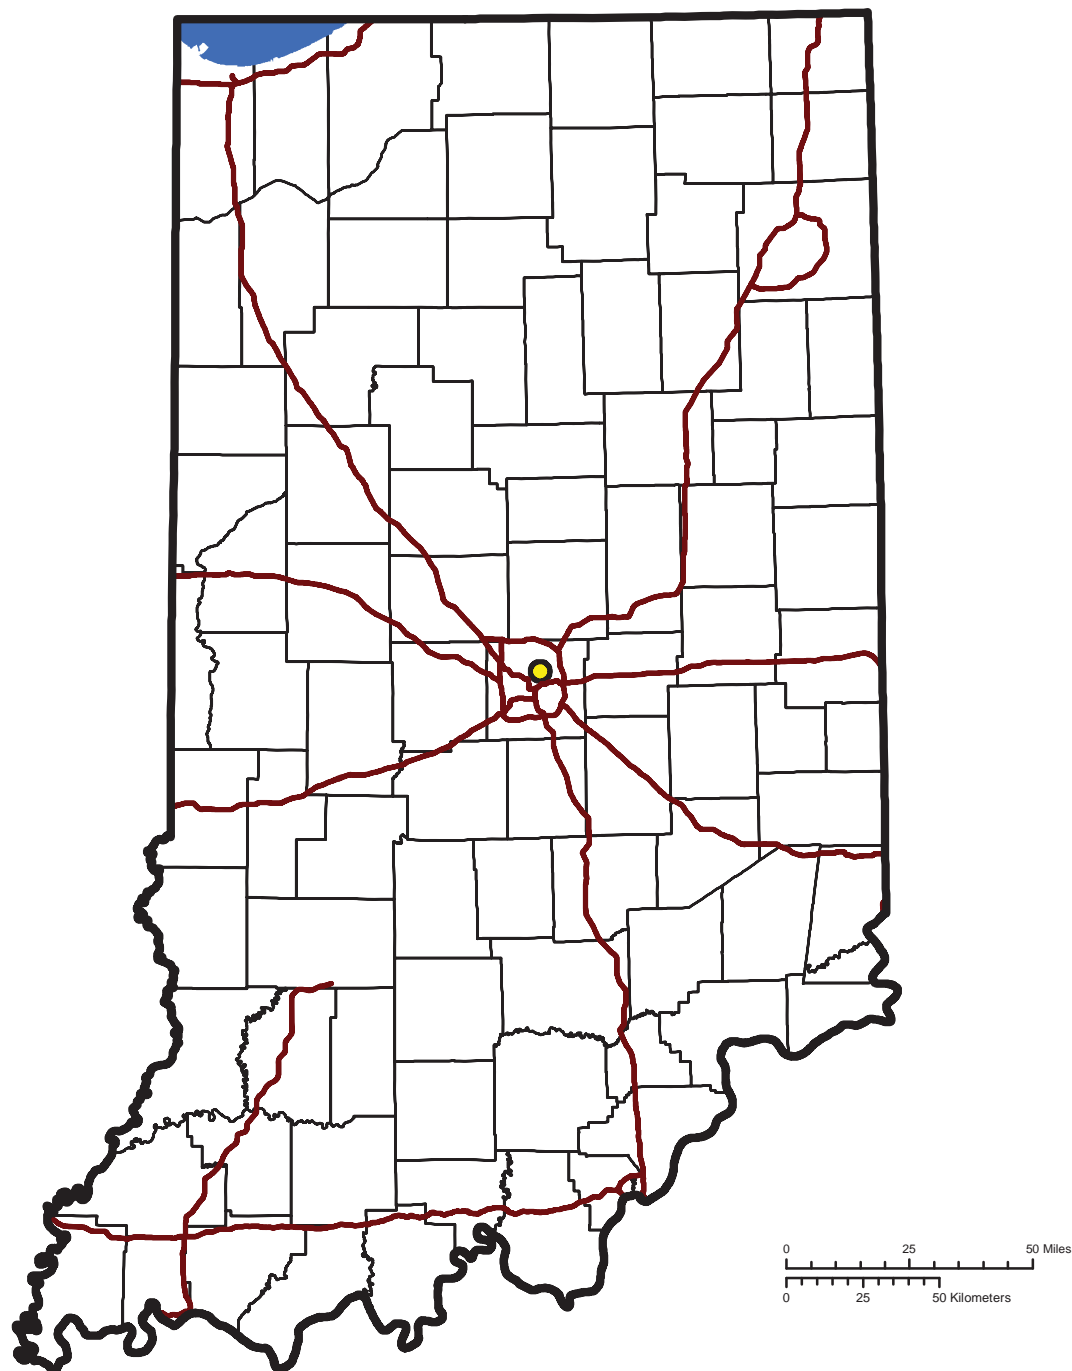
**Figure 1-1**

## Keystone Corridor Ground Water Contamination

### Indianapolis, Marion County, Indiana

General Location in the State: Central Indiana (Figure 1-1 of this HRS documentation record; Ref. 122, p. 1; 130, p. 1)

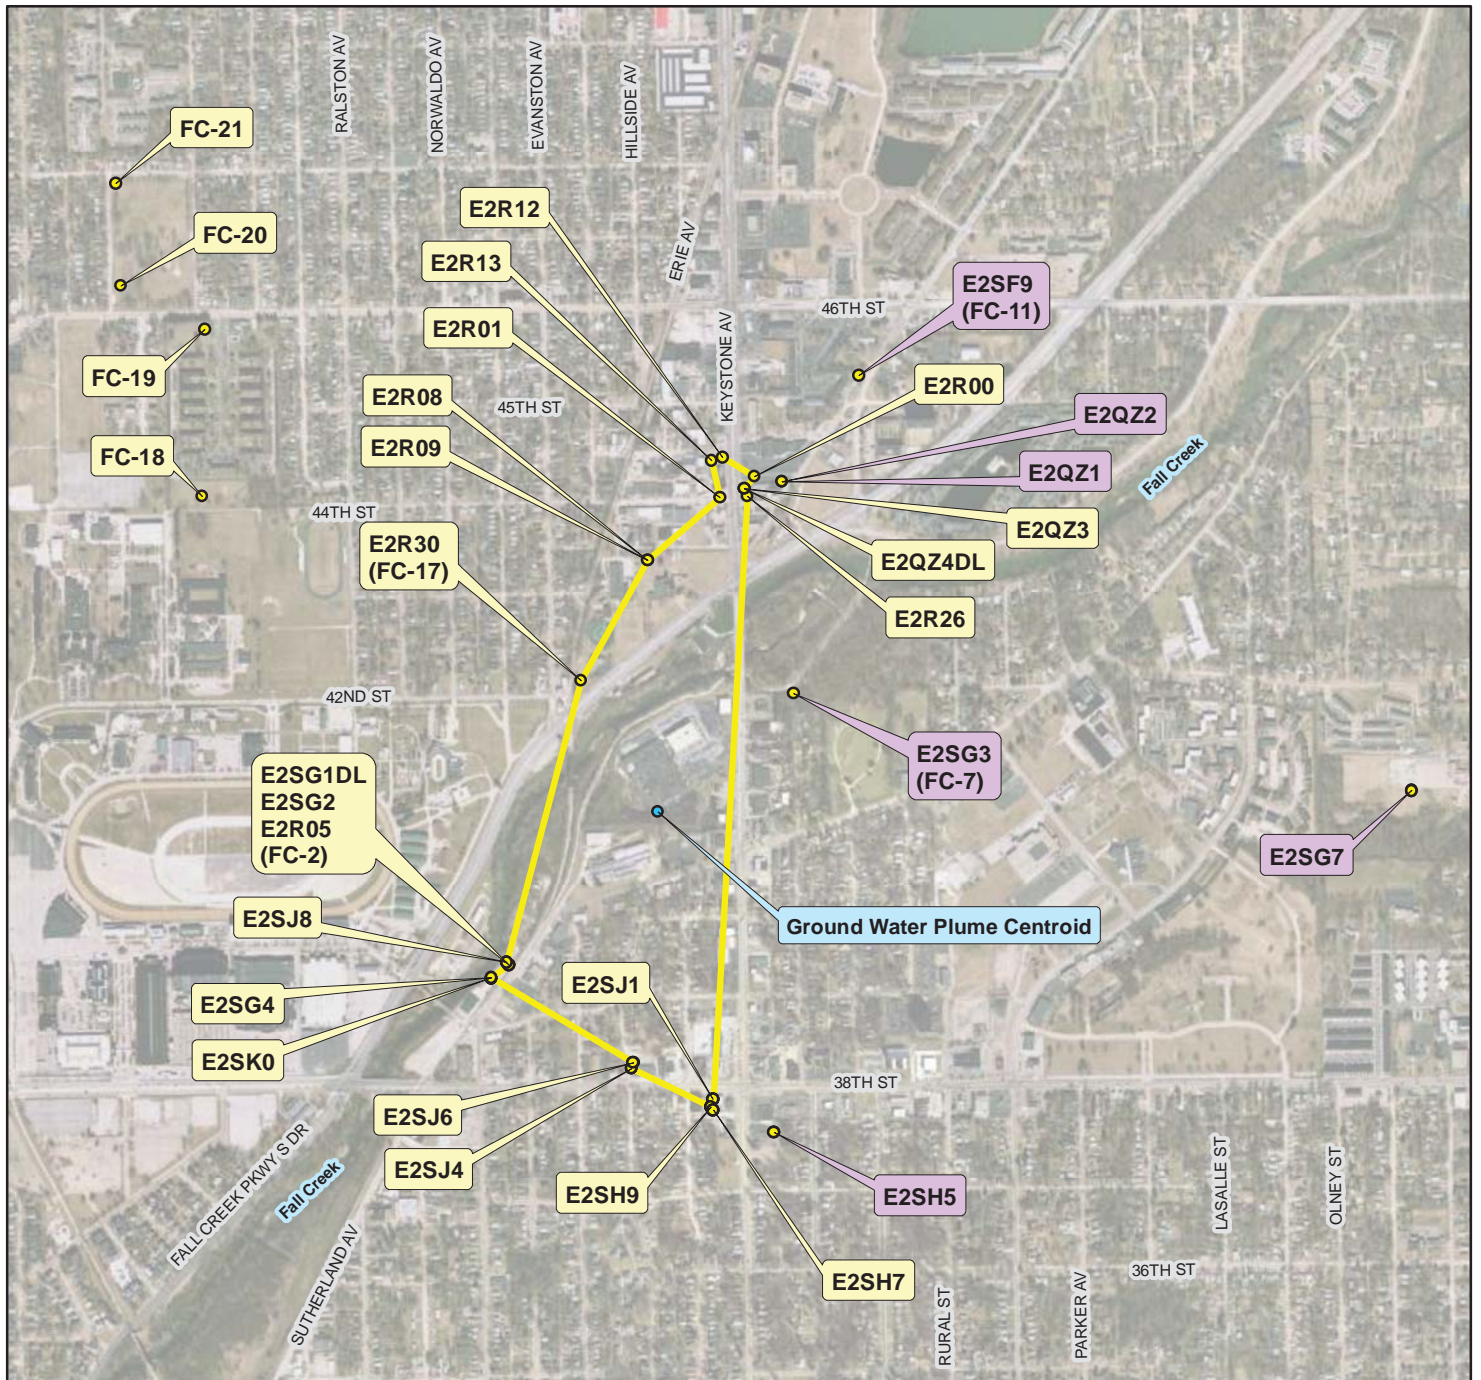
# Ground Water Plume Boundary - Keystone Corridor Ground Water Contamination Indianapolis, Marion County, Indiana

- Non-orthophotography data obtained from the State of Indiana Geographic Information Office (GIO) data library.
- The Ground Water Plume Boundary was digitized by connecting The ground water sample locations that meet observed release criteria.
- Background samples are shown in a purple text. calout.

The extent of the ground water plume is depicted by samples from direct-push wells, municipal wells and monitoring wells known to contain volatile organic compounds at concentrations that meet observed release criteria (Ref. Figure 1-3 of this HRS documentation record; 122, p. 1; 130, p. 1). The plume currently measures approximately 4500 feet long (north to south) and approximately 1500 feet wide (east to west) (Ref. 122, p. 1; 130, p. 1; Figure 1-3 of this HRS documentation record).

The area of the ground water plume is based on available samples that meet the criteria for an observed release (Ref. Contaminated Ground Water (Obtained by Direct Push) Sample Table of this HRS documentation record; Contaminated Ground Water Obtained From Established Monitoring Wells Sample Table 1 of this HRS documentation record; Fall Creek Municipal Well FC17 Table of this HRS documentation record; Contaminated Ground Water Sample Table 2 (Municipal Well FC2) of this HRS documentation record; Section 3.1.1 of this HRS Documentation Record). The plume boundary was digitized by connecting wells that met observed release criteria (Ref. 122, p. 1; 130, p. 1; Figure 1-3 of this HRS documentation record).

Background wells were identified outside the boundaries of the plume (Ref. 131, p. 7; 139, p. 1; Background Ground Water Sample Tables found in Section 3.1.1 of this HRS documentation record; Figure 1-3 of this HRS documentation record; 122, p. 1; 130, p. 1).
